# Manhole Inspection Summary

Manhole # S41A2\_007MH

Insp Date: **12/10/07 1:53 PM**

**Location** Address: **911 Washburn Ave**

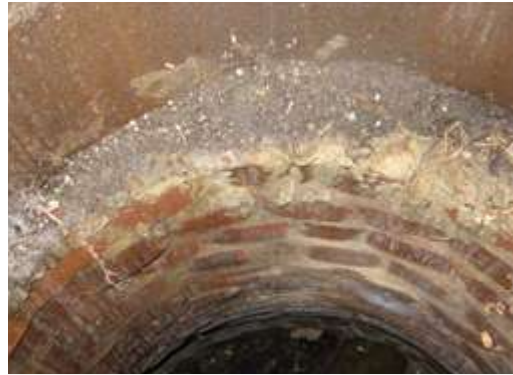
Defect 2

Offset: **4** (in.)

Frame offset

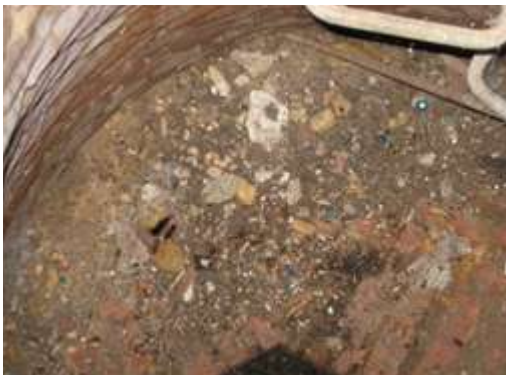
Defect 1

Debris

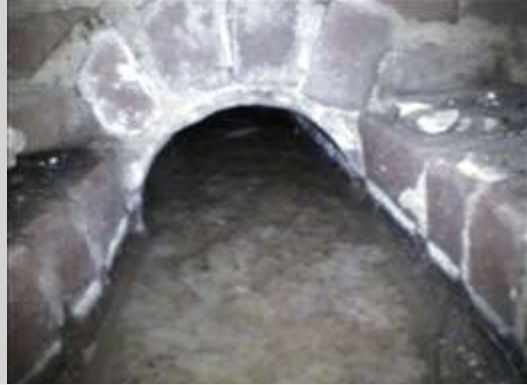
12 O'Clock Outflow

8 in. Circular Gravity Sewer  
Pipe Out @ 12 O'Clock

Pipe Height: **9.6** (in.) Rod and Bar (Angled)  
Pipe Material: **Clay** ☐ Pipe Lined  
Invert Depth: **7.04** (ft.) Flow Characteristics: **Slow**  
Deposits: ☐ None ☒ **Mud** ☒ **Gravel** ☐ Debris ☐ Grease  
Silt Depth: **1** (in.) Deposits Extent: **Medium**  
Infiltration: **None** Pipe Seal Cond: **Sound**

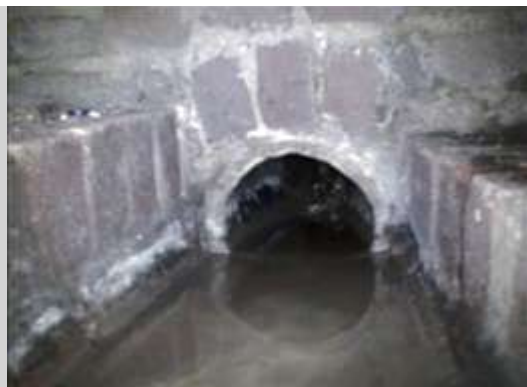
7 O'Clock Inflow

6 in. Circular Service Sewer  
Pipe In @ 7 O'Clock

Pipe Height: **7.2** (in.) Rod and Bar (Angled)  
Pipe Material: **Clay** ☐ Pipe Lined  
Invert Depth: **6.93** (ft.) Flow Characteristics: **Slow**  
Deposits: ☐ None ☒ **Mud** ☒ **Gravel** ☐ Debris ☐ Grease  
Silt Depth: **1** (in.) Deposits Extent: **Medium**  
Infiltration: **None** Pipe Seal Cond: **Sound**
